2021 Periplus to Northwest Passage 8th Edition

by Victor Wejer, Toronto, Canada, March 2021 vic11@bell.net

This Yacht Routing Guide to the Northwest Passage

by Victor Wejer is a compilation of further port and anchorage information which will be updated annually. The RCC Pilotage Foundation is very pleased to be able to make this guide available to you via a download from the RCCPF website. However, the RCCPF has had no part in the production of this guide and accepts no responsibility for the accuracy of the information contained within.

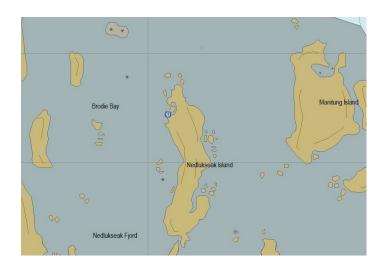
Nedlukseak Island 68°07'N / 65°57'W.

Within strong headwinds anchor in a small bight on the W side of the island in 8m close to the shore to gain the most shelter. Poor anchorage and exposed in westerlies. Charts still ½ Nm out. (Novara).

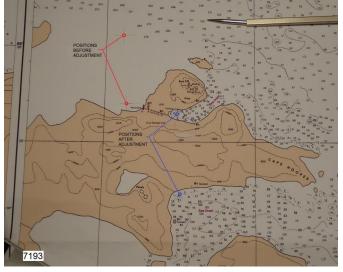
Upper Anchorage – Cape Hooper – 68°27.6'N / 66°48.7'W. A far better anchorage offering good shelter and good holding in 10m to 15m.

An emergency shelter and service huts ashore. 2.75 Nm offset from Navionics charted position. (Novara). For Upper Anchorage CHS states "...correction must be moved 2 minutes southward and 3' 36" eastward..."

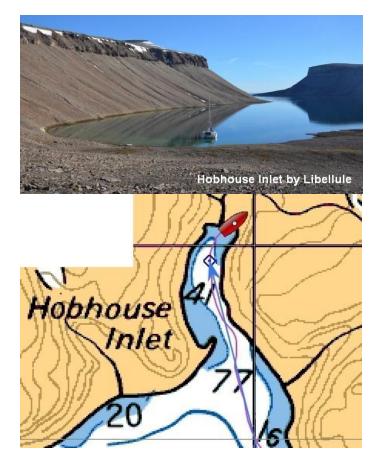
Hobhouse Inlet 74°30'N / 87°00'W.

Very deep up to shores, anchor in NE end. Charts are off by approx. 0.4 Nm West. Chart by *"Tooluka"*. Anchorage at 74°50.2236'N / 87°00.7635'W. Some sailors liked it, some didn't. (E.W.) No settlement.

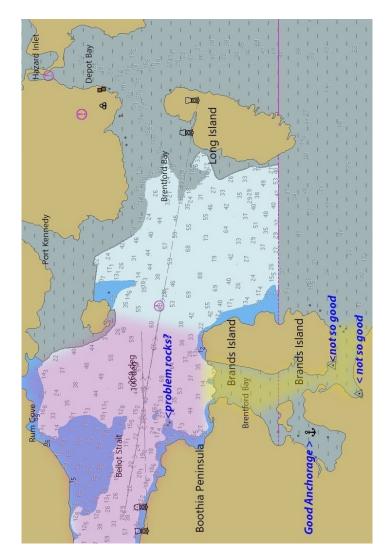
Near Ft. Ross a good shelter from ice and wind can be found in a bay WSW off **Brands Is.** at 71°57.70'N / 94°29.0'W. Holding is fair and shelter excellent. Entry can be taken via the channel south of Brands Is. Care must be taken on this route as, channels is generally deep, there are shoals and rocks that covers & uncovers during tidal water levels, some of which are uncharted. (L.R.)

The area referred to containing unmarked shoals was out of the main tidal stream; marked it in <u>yellow</u>. This area had much less current but the ice **was** moving in wind and current and ultimately caused to reject anchorages at the

Island. While obviously, ice can be anywhere, there was no current in this bay and do not believe there is enough fetch for wind driven ice to seriously threaten a small vessel. Still recommend this anchorage but, in the light of the events of the last 2018 summer, the approach and exit south of Brands Island might be the safer one, particularly if there is ice around.

The eastern approach to Bellot is very unfriendly other than at slack water. The description of ice coming from every direction is very much what can be expected when the tidal current is flowing. It is a very serious place for small boat navigation!

Approximate wreck location of 2018 "s/v Anahita" (FRA) is at 71°59.48'N / 094°25.15'W in 48 mtr.

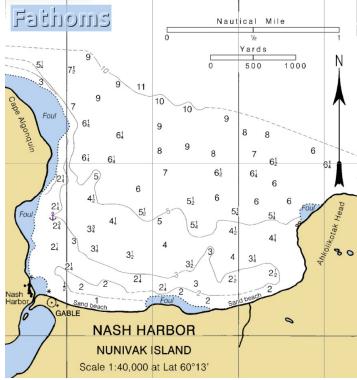
Nash Harbor 60°12.69'N / 166° 56.16'W. Quaint place from all but Northerly winds, some kelp evident. Used for shelter by many. (W.S.)

Nunivak Is. $60^{\circ}20$ 'N / $166^{\circ}37$ 'W. This little bay next to Nash Hbr. offers some landing. Watch for plenty of kelp primarily on the south shores and dangerous shoaling in Etolin Str.
