RCC Pilotage Foundation Cruising Guide to West Africa

Notes and Updates

Robert Fox

December 2016 - April 2017

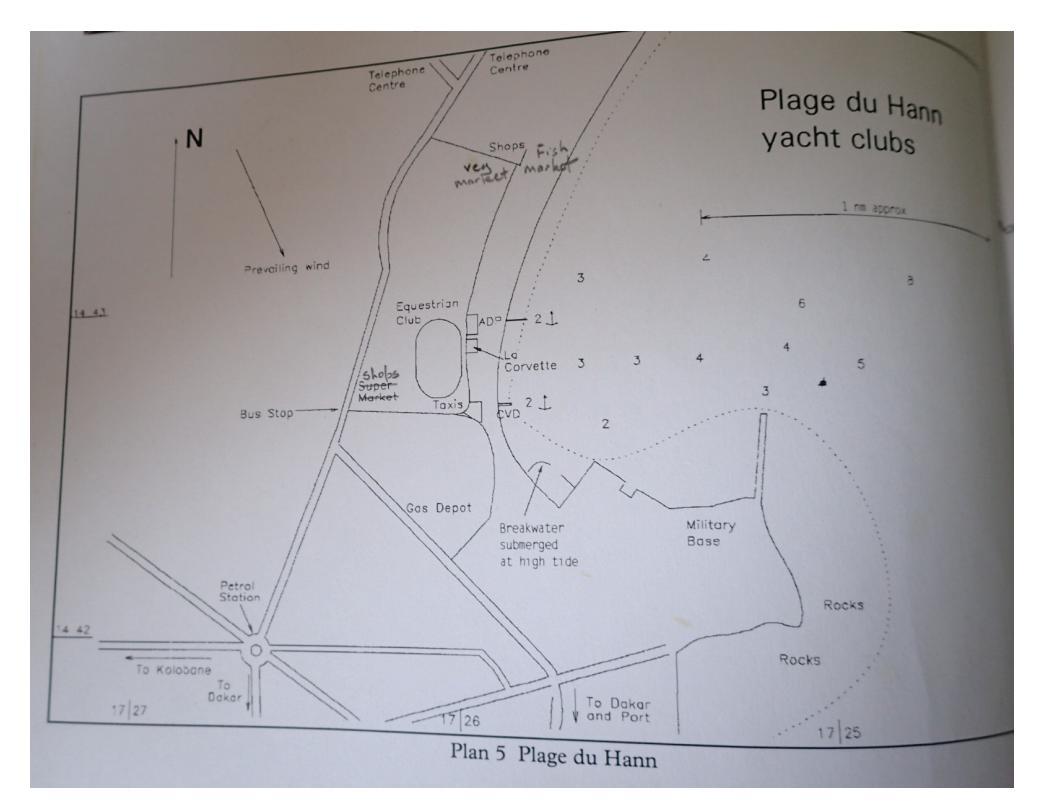
Figure 2: Plan 5

Plan 5: see figure 2. The Super Market shown on Plan 5 no longer exists but there is a vegetable market and a fish market as well as shops where indicated near the north of the plan. I found (in December/January) that the prevailing wind usually had a larger onshore component than would be expected from the plan.

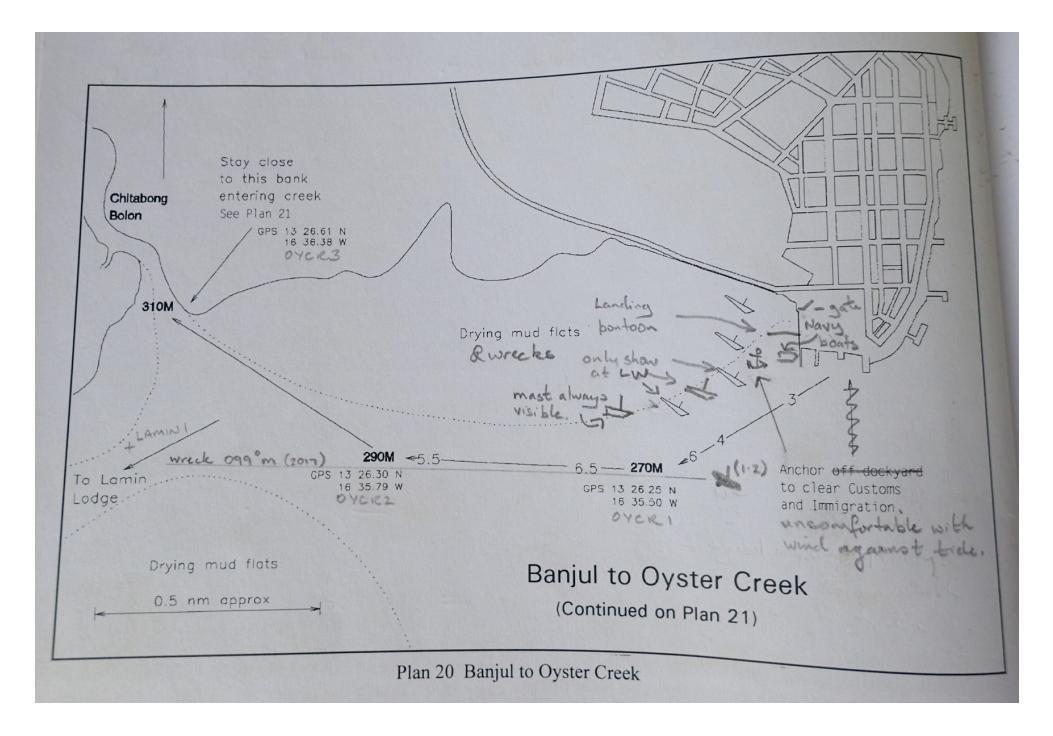
Figure 3: Plan 20

Page 44 & Plan 20: I anchored off the former boatyard at Half Die as shown on the original Plan 20. I was boarded almost immediately by the Navy and asked to move to the other side of the pier where their power boats are moored, probably the location described by Bob and Liz Cooper. There are a lot of unmarked and dangerous wrecks in this area.

Page 47 and Plan 20: I found pilotage in the area of Plan 20 difficult. There are a lot of wrecks and not many landmarks.

The 1.2 m wreck shown south of the channel on Admiralty Chart 608 is always visible and a useful landmark. The mast of another wreck on the north side of the channel is also visible at high water but there are other dangerous wrecks close to this one that are usually submerged. I have sketched some extra details on Plan 20 (see figure 3) but stress that these are very approximate and navigation in this area must be undertaken with great care. I failed to find the entrance to Chitabong Bolon either by traditional pilotage or by using the GPS waypoints given in Plan 20. I ran aground several times trying (i.e. depth less than 1.8 metres), fortunately all in soft mud. This was an hour or two after low water. Whether my pilotage was at fault or the entrance has moved or shoaled I don't know. In the end I gave up and went to Lamin Lodge instead. Unfortunately I never got round to going back and surveying the area by dinghy. I did note several yachts and some large fishing boats in Oyster Creek when passing on the bus but they may have been there for some time.

I did find the GPS waypoints given in Plan 20 very useful for staying in the main channel.

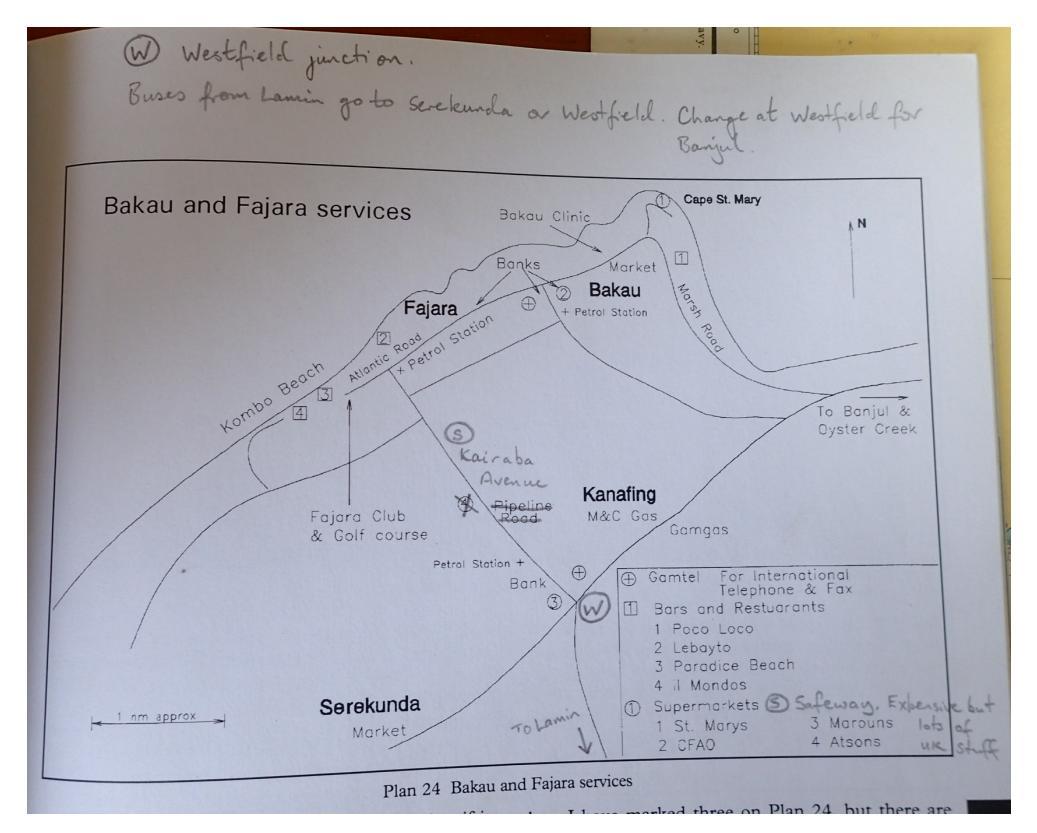
Figure 4: Plan 24

Plan 24: see updated sketch in figure 4. Pipeline Road is now called Kairaba Avenue. Some of the supermarkets have moved or changed.

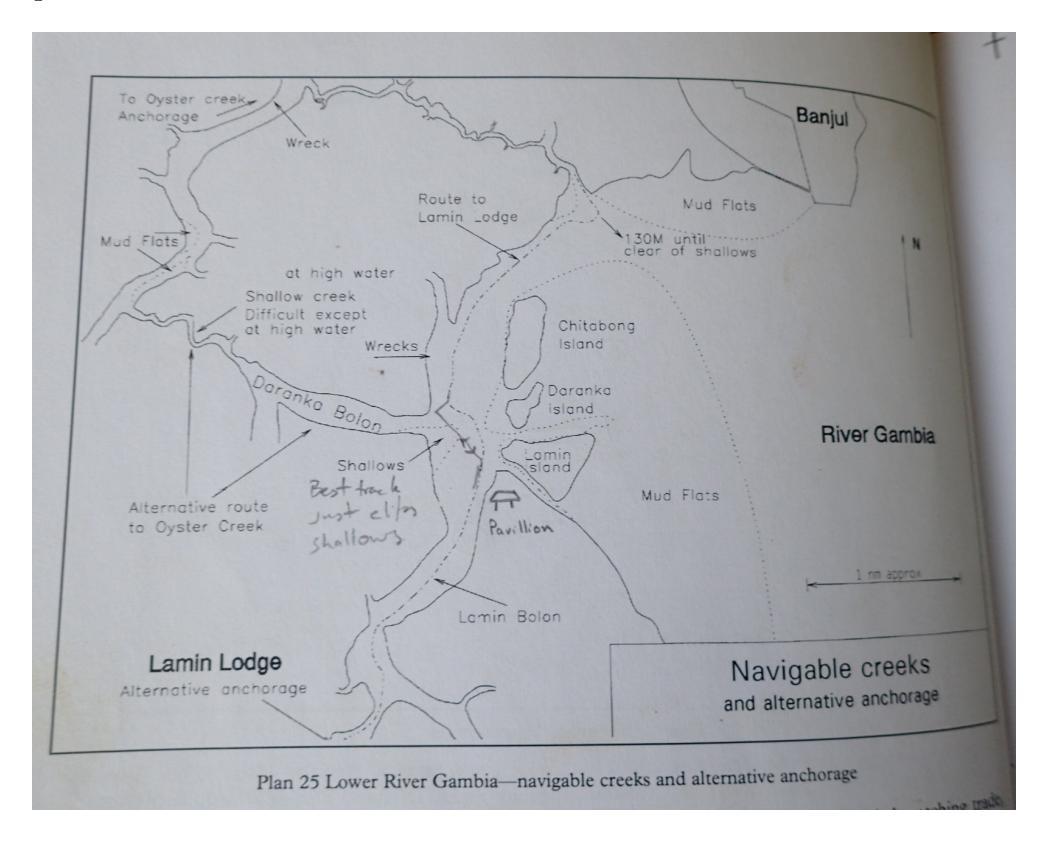
Figure 5: Plan 25

Page 53 and Plan 25: the shallows in the area where Daranka Bolon joins Lamin Creek are very extensive. A pavilion on the tip of the mainland just south of Lamin Island makes a useful landmark. The deepest track I could find was to stay quite close to the west bank right up to the north west point of the entrance to Daranka Bolon and then head straight across to the point of land just north of the pavilion. I could just follow this track at low water (depth about 2 m) but the shallows are very close to starboard. See figure 5.

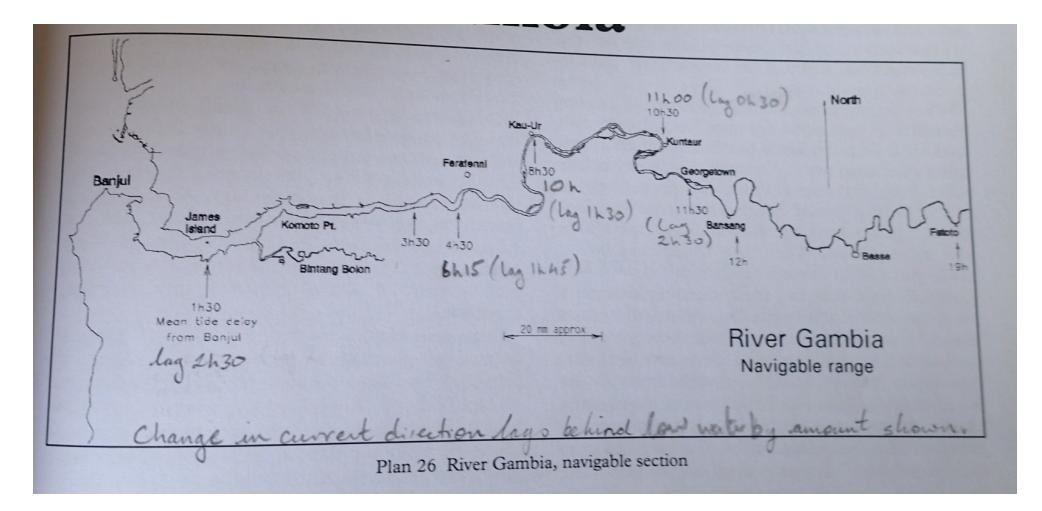
Figure 6: Plan 26

Plan 26: Plan 26 gives the times of high and low water relative to Banjul but I found that the current generally did not reverse until a long time after high or low water. At James Island the delay was about $2\frac{1}{2}$ hours, decreasing to about 30 minutes by Kuntaur and then increasing to $2\frac{1}{2}$ hours again by Georgetown. I have noted these times in figure 6 but they are very approximate.

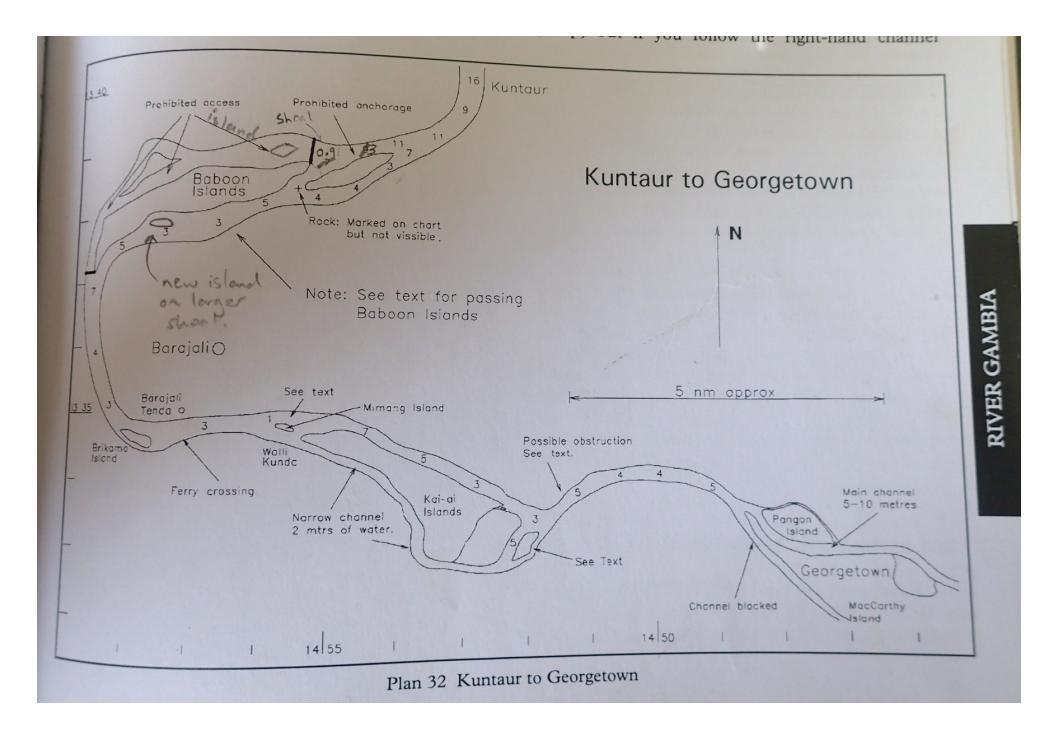
Figure 7: Plan 32

Plan 32: there is an additional small island in the channel north of the largest Baboon Island, this is shown on Admiralty Chart 609 but not on the original Plan 32.

Part of the shoal shown south of the largest island on Admiralty Chart 609 is now a new island.

Page 66 and Plan 32: as reported by the Coopers, the depths in the channel north of the small island before Baboon Island are much less than charted, to the extent that many yachts will not be able to use this channel at low water. I slid over a shoal in this channel at half tide and calculated that there would be less than 1 m at chart datum. This was close to the position where plan 32 shows a depth of 7 m. The depths in the south channel were more or less as charted.

Refer to figure 7.
